# RESEARCH MEMORANDUM

PRELIMINARY RESULTS OF SUPERSONIC-JET TESTS OF  
SIMPLIFIED WING STRUCTURES

By Richard R. Heldenfels and Richard Rosecrans

July 8, 1953

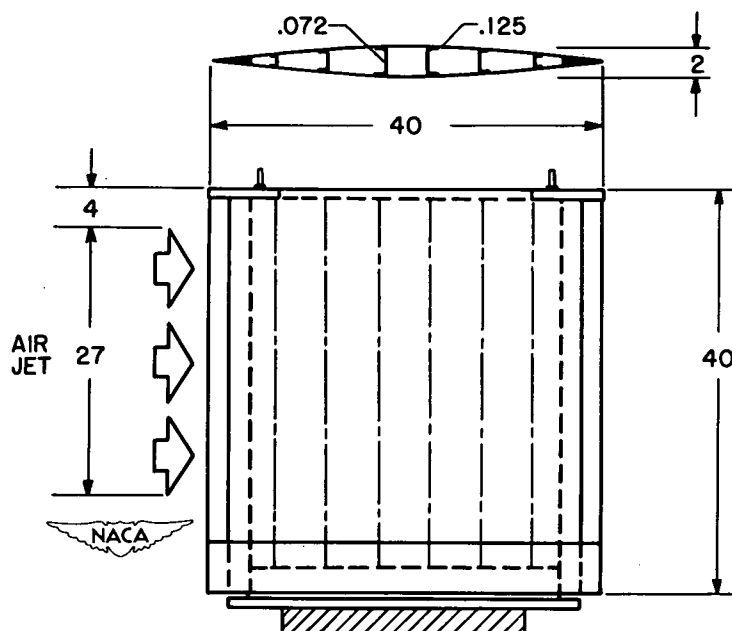
The model chosen for the first test was a somewhat idealized section of an untapered multiweb wing as shown in figure 1. The airfoil section was a 5-percent-thick symmetrical circular arc and the model was constructed of 24S-T3 aluminum alloy except for the bulkheads and mounting fixtures which were of steel. The model was mounted vertically in the jet at an angle of attack of  $0^{\circ}$  with its leading edge just downstream of the nozzle exit plane. The model extended completely through the jet with about  $2/3$  of the span in the airstream.

Figure 1.- Configuration of model MW-1.

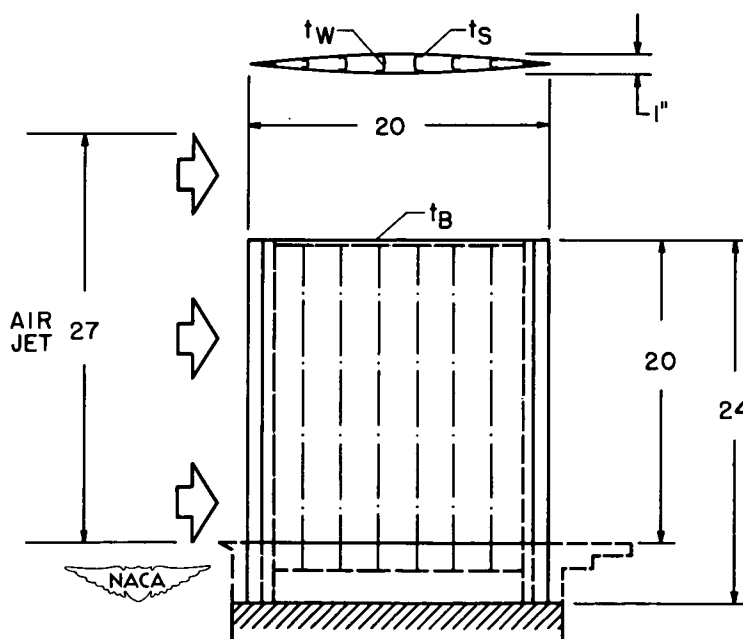
Figure 2.- Configuration of models MW-2, -3, -4, and -7.

Model MW-3 was nearly identical to model MW-2, as shown in figures 2 and 4, except for the skin thickness which was increased from 0.064 to 0.081 inch. This change not only increased the critical stress of the skin but also decreased the thermal stresses induced during the test. This model showed no signs of distress when tested at zero angle of attack. The 27-percent increase in skin thickness was thus sufficient to prevent buckling and failure. This model was also tested at angles of attack of  $1.5^\circ$  and  $3^\circ$  and survived both without difficulty. In the final test at an angle of attack of  $5^\circ$ , however, the model failed statically. This failure was expected since the calculated aerodynamic loads were about 1000 pounds per square foot, enough to cause compressive buckling of the skin near the root.

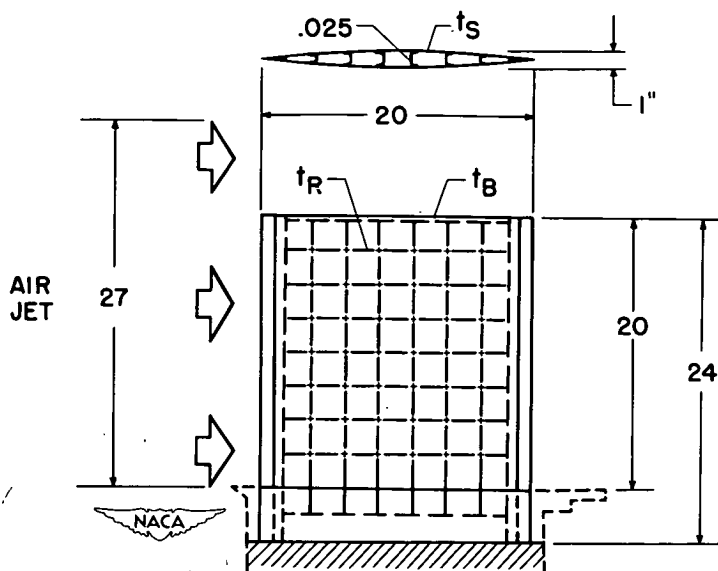
Figure 3.- Configuration of models MW-5 and -6.

Models MW-5 and MW-6 incorporated chordwise ribs as shown in figures 3 and 4. These ribs were the same distance apart as the webs, forming square skin panels, so that the critical stress in the chordwise direction was raised to a safe value. Model MW-5 was similar to model MW-2 except for the ribs, whereas model MW-6 had a thinner skin, with a thickness of 0.050 inch instead of 0.064 inch. The thinner skin should lead to higher thermal stresses and lower critical values; however, the stresses should still not exceed the critical. Each model was tested at an angle of attack of  $0^\circ$  and survived the test in good condition.

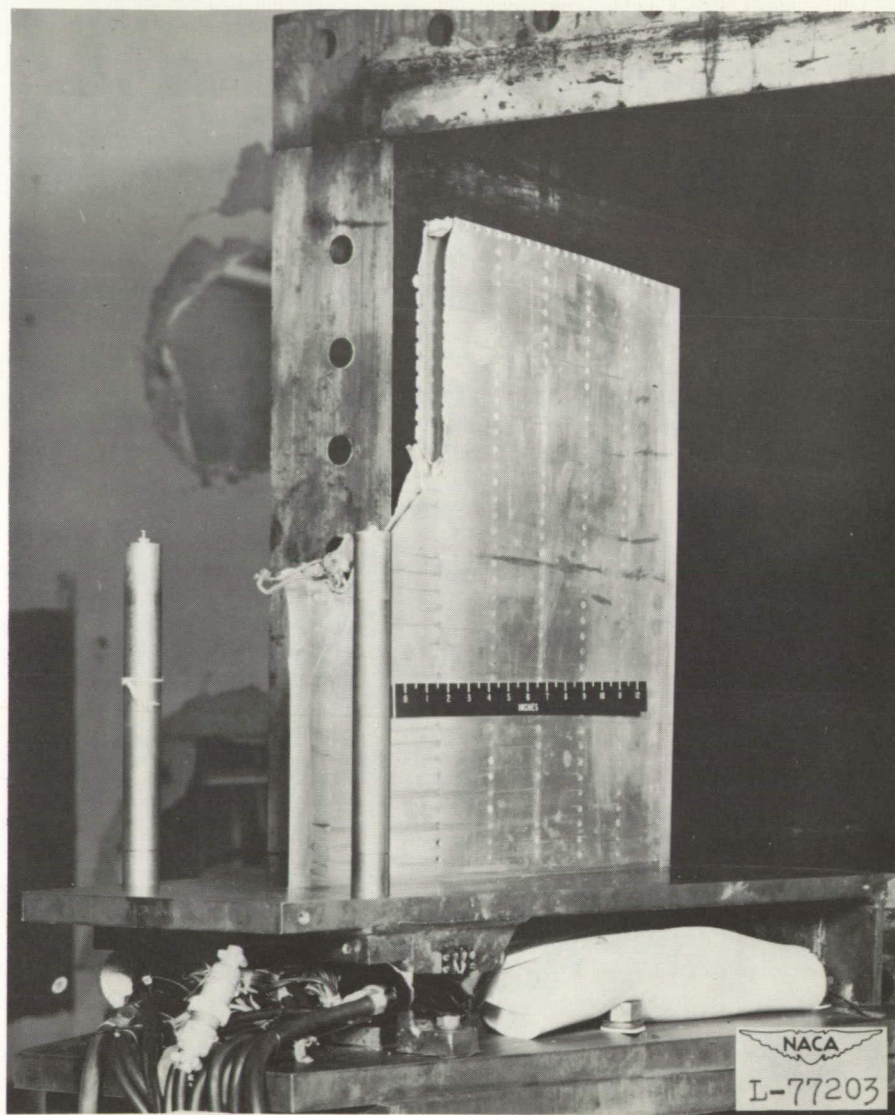
Figure 5 shows model MW-2 as it appeared after the test. The extent of the failure and the manner in which the model was mounted in front of the nozzle exit can be seen. The two masts downstream of the model were used to support stagnation temperature probes which were broken off by fragments of the model.

The failure of this second model was fundamentally the same as that of the first in that skin buckling induced the model to flutter and then fail. Certain differences were evidenced in the shape of the buckle and the longer time required to induce failure. These differences can be explained in part by the change in detail design, particularly in the tip region, and the resulting changes in the thermal stress distribution.

The skin of this model was heated very rapidly, a point near the leading edge rising from 74° F to 400° F in 10 seconds, at which time the skin temperature was beginning to stabilize although some of the webs had risen to only 240° F. This temperature distribution induced thermal stresses in the model, particularly compressive stresses in the hot skin. Differential expansion between the skin and webs caused compression in the spanwise direction, whereas the restraint offered by the tip and root ribs created compression in the chordwise direction. Approximate calculations and the recorded strains indicated that these two types

of stresses were of about the same order of magnitude, around 6000 psi. The chordwise stresses were the more important, however, because the stresses in this direction were of the same order of magnitude as the critical chordwise compressive stress. This critical stress was only  $1/4$  of the critical stress in the spanwise direction because of the long narrow skin panels. The concentration of the buckling near the tip indicates that the tip rib was a major factor, an observation further supported by the fact that the initial fracture was apparently a tension failure of the tip rib at a section weakened by several rivet holes.

Figure 5.- Remains of model MW-2, in place at nozzle exit, after test.

The results of this test indicate that the immediate cause of failure, chordwise flutter, was induced by thermal buckling of the model skin. If this analysis is correct, then, both flutter and the resulting failure should not occur if buckling is prevented. Structural changes that may prevent buckling are an increase in skin thickness, a reduction in the stiffness of the tip rib, or the addition of transverse ribs. Each of these changes has been incorporated in a test model. Changes in the root connection have not yet been investigated because the test of model MW-2 indicated that the buckling occurred in the tip region.

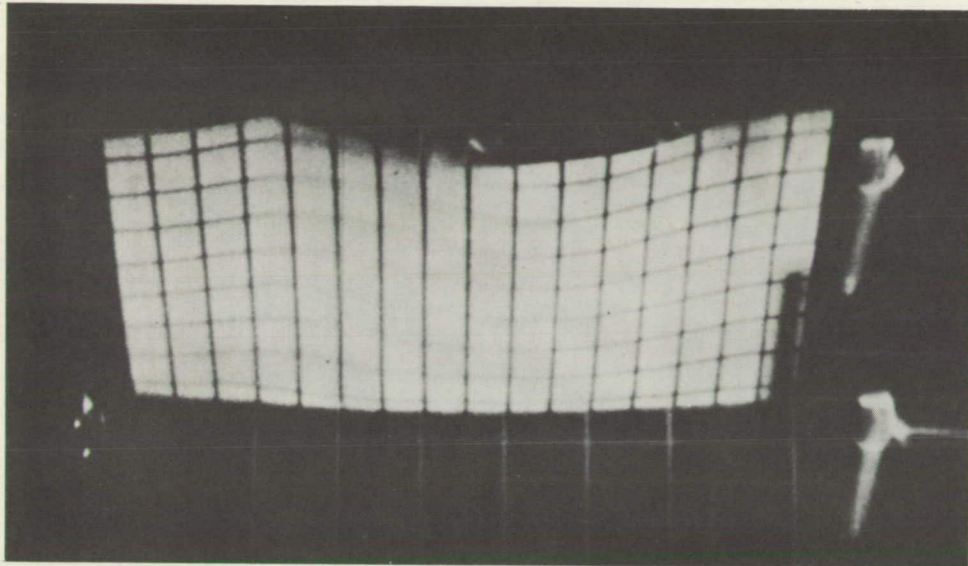
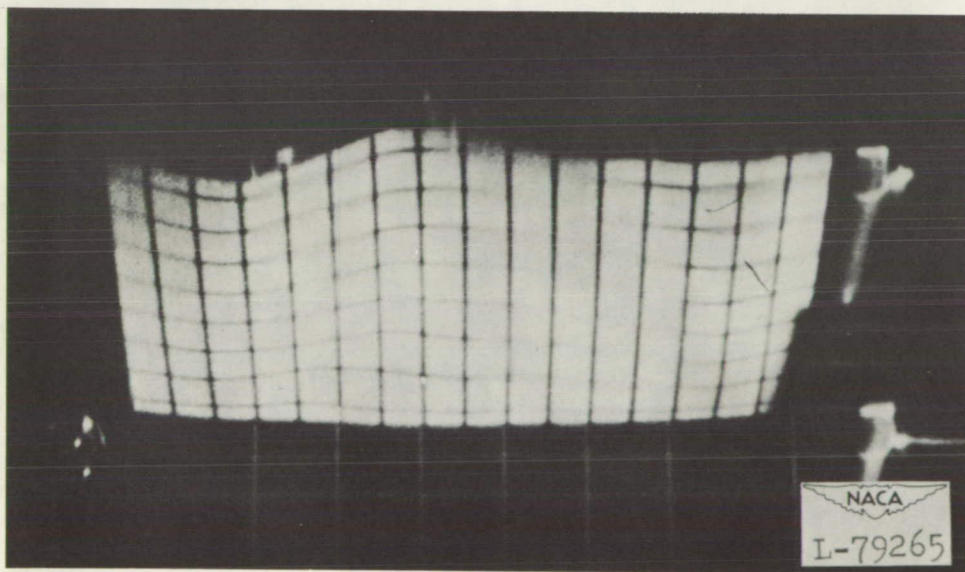
The chordwise flutter mode of about  $1\frac{1}{2}$  waves along the chord can be seen in figure 6 which presents two consecutive frames from the 650-frames-per-second motion picture. The model, which was painted with a grid to aid observation, is viewed from above and to one side; the air flowed from left to right. At the time these pictures were made, the flutter had become severe and the model was completely separated from the supporting structure 12 frames later.

The analysis of this test has not yet been completed, but the preliminary results show that model MW-4 was fluttering at 240 cycles per second, about the same frequency as model MW-2. The amplitudes were larger on model MW-4, however, because the light tip bulkhead offered very little resistance to chordwise distortion. The large reduction in the stiffness of the tip bulkhead was thus completely ineffective in preventing failure since the failure occurred sooner and more violently.

In the case of models MW-1 and MW-2 it was concluded that flutter was incited by skin buckling, but in the case of model MW-4 flutter was obtained without obvious buckling of the model skin. A change in the effective stiffnesses (and thus in natural frequencies) of a model may incite flutter. Skin buckling of models MW-1 and MW-2 made an obvious change in the effective stiffness; whereas in model MW-4 a more subtle stiffness change must have taken place because of the spanwise thermal stresses induced in the model; especially the compressive stresses in the skin. Model MW-4 was particularly susceptible to a critical stiffness change because of its low initial chordwise stiffness.

Figure 6.- Distortion of model MW-4 just prior to failure (taken from consecutive frames of motion picture).
